SMT Adviser
Kazuo Kawai
E-mail:jitusougiken@ybb.ne.jp

3D Digital Microscope

I) Reflow	2
1) Temperature profile	2
2) Self-alignment effect	3
3) Reflow of applied solder	4
4) Reflow of through-through-hole components	5
Examples of soldering failure	6

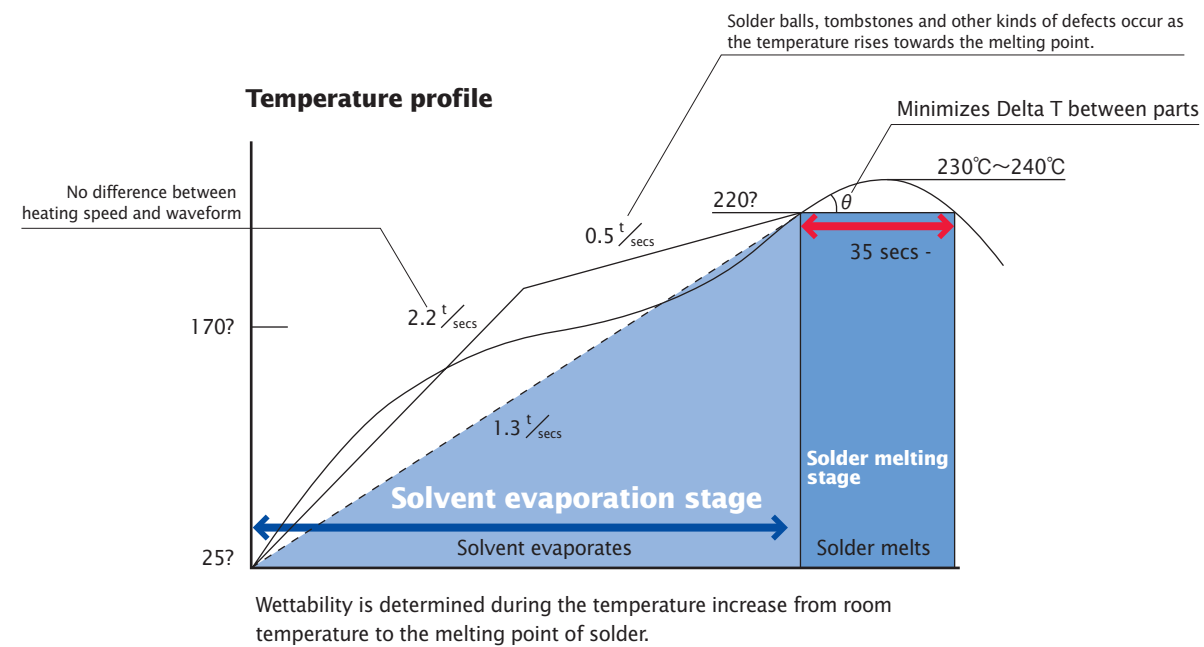
Preparation of temperature profiles

Solder does not wet unless it melts. Therefore, the temperature difference between leads (Delta T) should be minimized within the tolerance range during solder being melted, but not necessarily during the pre-heat stage. Minimizing Delta T in the pre-heat stage can lead to a greater delta T within a solder melting temperature, possibly resulting in longer heating or stronger convection, a direct cause of flux burnout and thermal stress on PCBs and components.

Recap: Delta T must be minimized during solder melting phase (as shown with red arrow) but not necessarily pre-heating (as shown with blue arrow).

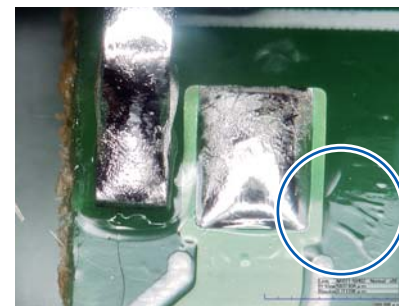
Picture 1: Spattered flux residue may cause poor wetting or create voids.

Residual flux (Picture 1) spattered by strong convection and (Picture 2) residual flux after adjustments of air flow.

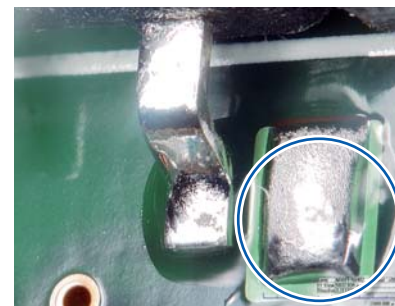
Picture 2: Normal flux residue as a result of proper flux activation to heat between land and leads.

Flux reacts with heat first on an entire mounted PCB. Under the normal profile, flux reacts on component leads. Thus, observation of residual flux is important.

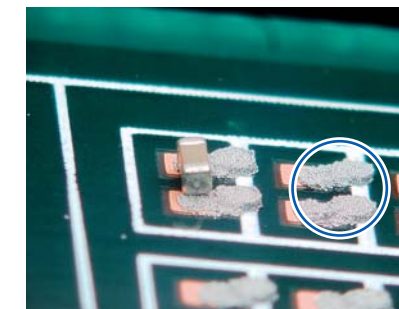
Flux moves while reacting to heat on lands. Melted solder shifts to the area where flux moves. Components shift with solder and stay on the lands.

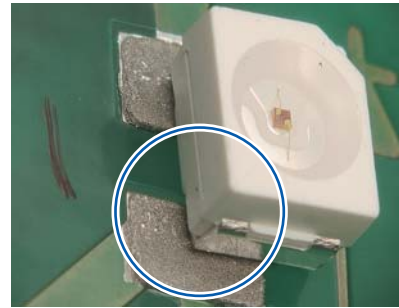
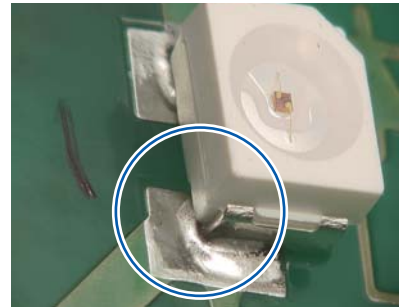
Even with a good temperature profile, self-alignment will not occur if there is insufficient solder printed. A proper amount of solder is required to take advantage of the self-alignment effect.

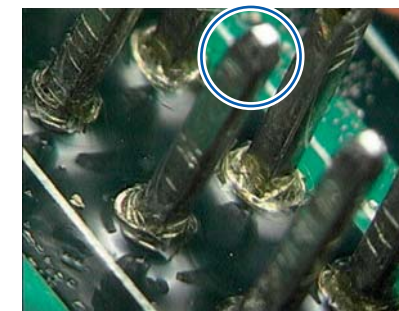
Picture 26

Selection of solder and printing conditions are key factors to determine solderability.
Residual flux found on both sides of the through-hole is an indication of good soldering.
No bridges despite leads inserted from the bottom side. (Pictures 26 and 28)

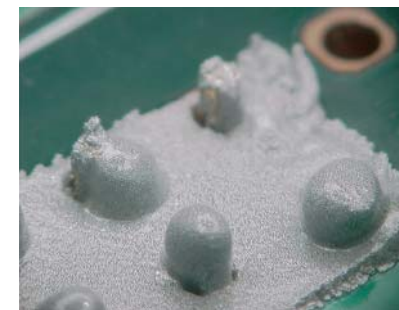
Picture 27: Solder reacts to heat on leads and no bridges are formed despite bold printing.

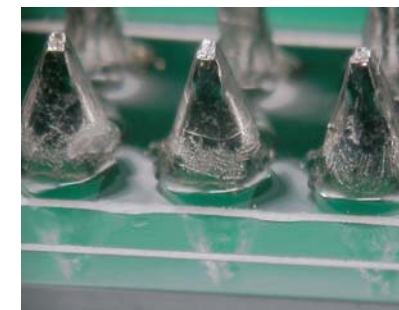
Picture 28: Residual flux stays on printed area of solder paste.

Printing side and insertion direction of leads are at manufacturer's discretion. Thin and well-spread solder printing allows flux to react to heat. Flux needs to react to heat quickly and stay within the printed area.

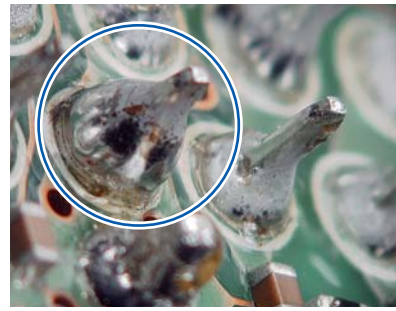
Combining the printed solder with the land increases thickness, resulting in slower heat reaction and a higher risk of bridge formation.

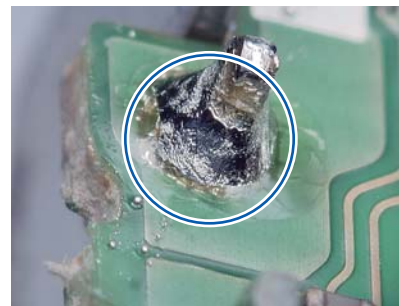
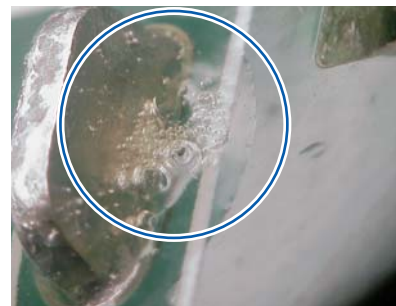
Using higher temperature resistant flux causes spattering. The selection of solder (flux) is extremely important in order to prevent bridges from forming and/or insufficient solder which can cause voids to occur more frequently.

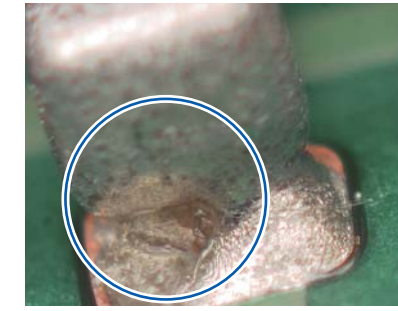
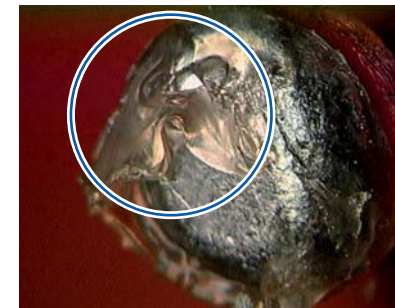
The temperature at the tips of the leads is lower due to the solder melting temperature and the flux vaporization overlapping, and/or the residual high temperature resistant flux repelling the solder.

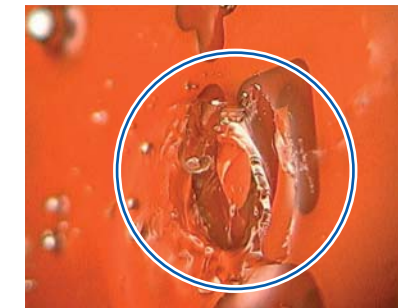
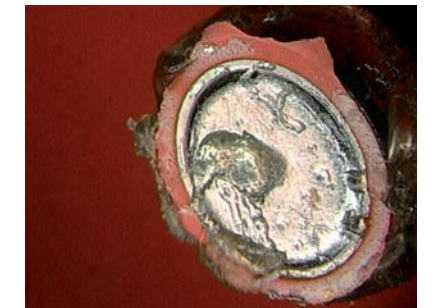
In these pictures of solder and residual flux on an FPC, there is a significant amount of residual high temperature resistant flux. This leads to voids on the bottom of fillets. (Pictures courtesy of Yuyama Co. Ltd.)

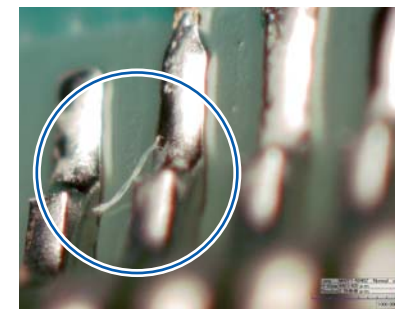
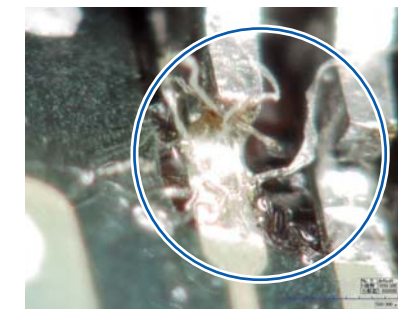
Although they look like fibers or hair, these pictures show residual flux. The location of this phenomenon cannot be specified.

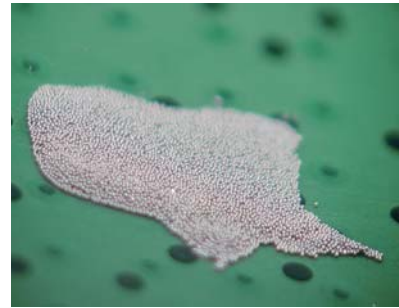
Picture 49: Company A

Solder is printed on the FPC resist, quickly connected and placed in the oven. When the first FPC leaves the oven, the oven is turned off, the cover opened and the FPC removed.

At this point, the order of the oven heating elements, the temperature profile and the FPC order are recorded. The spattering of solder and flux is checked afterwards.

The photographs show that a significant amount of temperature resistant flux did not evaporate and remain on the FPC and around the solder. If the heat is not properly balanced, this causes voids on the bottom of the fillet.(Picture 50,51,52) This is also true for a rigid circuit board. Solder from Company A(Picture 49,51) on the board does not melt, but solder from Company B(Picture 50,52) has melted. Even if the metals are the same, different flux (solvents, etc.) have different melting points. Solder from Company A requires higher temperatures and is not appropriate for parts or boards with low temperature resistance.

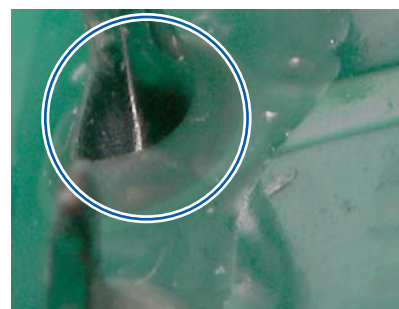
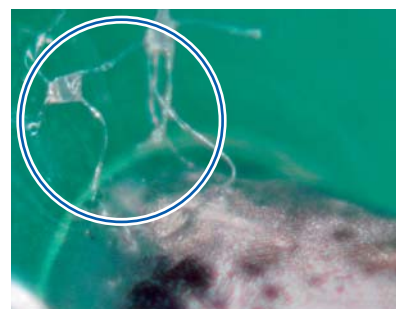
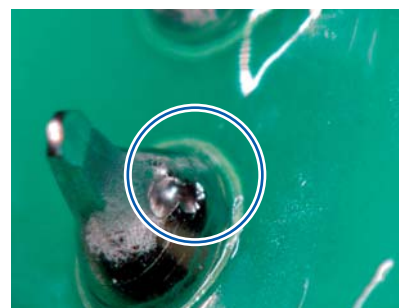
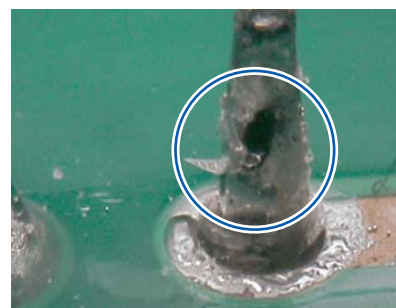
Residual wire solder using high temperature resistant flux and blowholes.

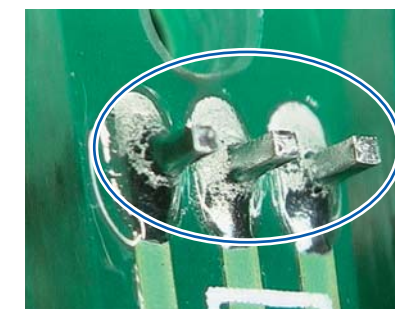
Picture 67: Heat dissipation from the pattern during manual soldering creates good gloss on the fillet.

The opposite is true with robot soldering. Heat escapes from the pattern and immediate cooling creates good gloss on the fillet.(Picture 67) Also, since flux deteriorates quickly on ceramic boards, solder wetting is achieved by heat from the bottom heater causing the flux to spread to the land first.(Picture 66)

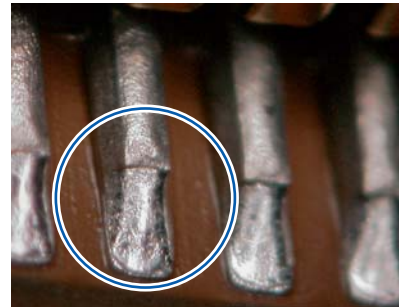
Picture 71: Peak temperature of 255 degrees

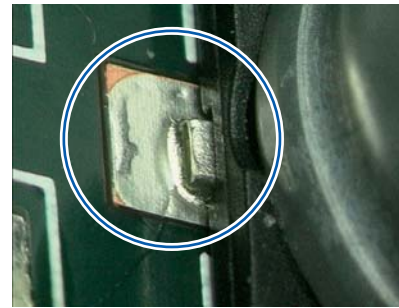
Picture 87: Replaced with bigger land

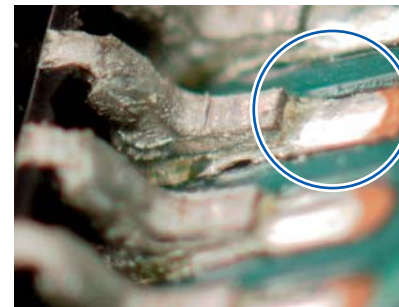
After 1000 heat cycles, the solder on the leads has been strongly affected by heat. However, the effect of heat on the front fillet is hardly visible, thanks to the release of heat from the land surface.

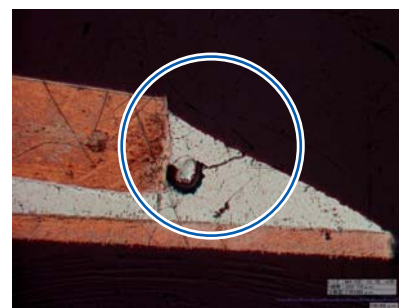
Picture 93 (enlarged view of picture 91)

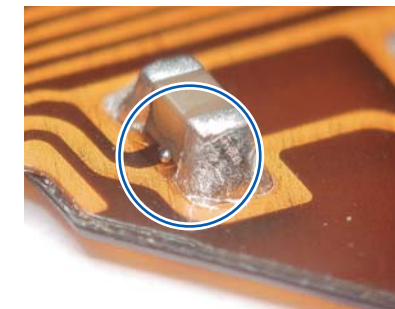
Picture 96: Image taken using a Rotary-Head Adapter (MX-5040RZ)
Side balls from excessive solder printing

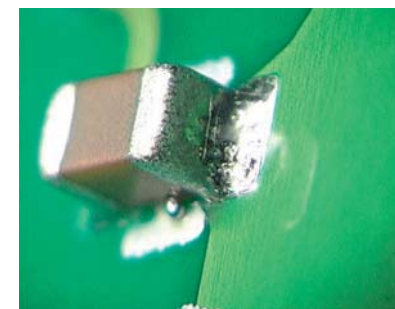
Picture 101: Solder wicking

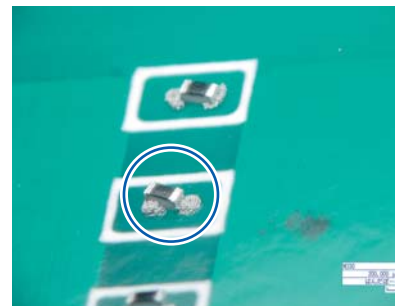
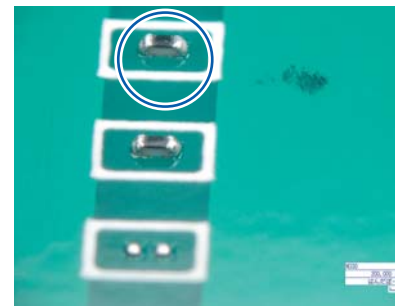
Picture 107: 0402 chip

Picture 108: 0402 chip

When simultaneously mounting parts with different amounts of solder and heat balances, a bottom side infrared heater can be used to provide heat directly to the circuit boards without having an effect on the parts on the bottom. The upper heater controls the melting of solder and prevents deterioration. Excluding special circumstances, the top temperature needed to melt solder is between 230 and 235 degrees Celsius.

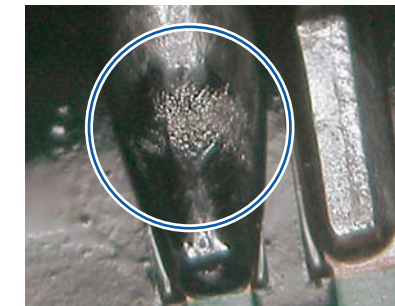
Solder is printed and reflowed on a straight joint so that it covers the resist deep on the lead. When solder wicks from the backs of sufficiently plated leads to the tips, wettability can be preserved even if the plating is not entirely adequate. If the temperature profile is appropriate, all solder of the resistant aggregate on the land.(Picture 115,116)

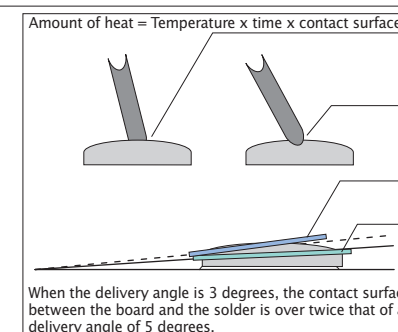
When the delivery angle is 3 degrees, break away time from the solder pots is slow and sufficient heat is supplied.

When the delivery angle is 5 degrees, insufficient heat causes the part lead to quickly break away from the solder pot.

Delivery angle of 5 degrees

Delivery angle of 3 degrees

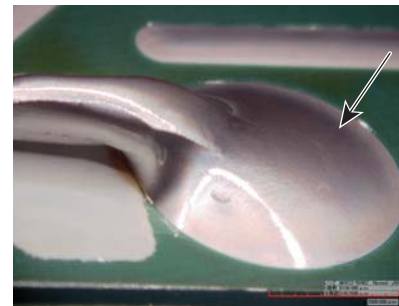
If the flux is effective, setting the delivery angle of the board to 3 degrees creates a large contact surface between the board and the solder. Supplying a large amount of heat without increasing the temperature in the solder pots improves the wetting at through holes through all layers of the board and reduces bridges. In order to stop flux from softening and flowing in response to heat, the ability of flux to flow from the solder pot to the board must be maintained. Solder balls break away with excessive heat, and a lack of heat controls solder flow and hardens the balls. (Picture 120,121)

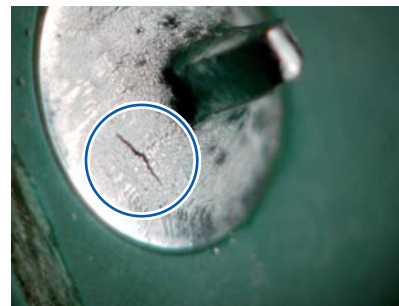
Picture 123: Normal state of applied solder

With normal flow solder, a large amount of heat causes dendrite formation and shrinkage cavities. (Picture 123) If the conditions are good, lead-free solder will not produce shrinking cavities. Setting the conveyor belt speed over 1.7 m/minute alleviates the problems of shrinkage cavities and dendrite formation. This depends on the abilities of onsite personnel. (Picture 124,125)

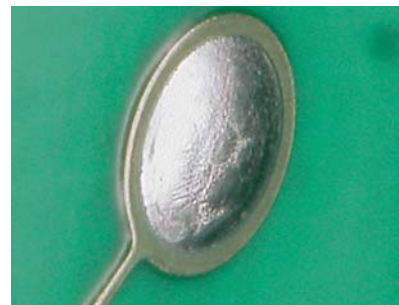
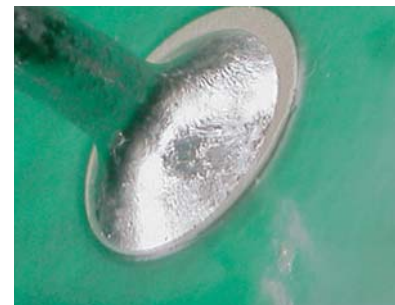
Picture 124

8-layer board with solid lands, temperature below 250 degrees and an immersion time of less than 5 seconds
Solder wetting to the top of the lead and shrinkage cavities, no dendrite formation

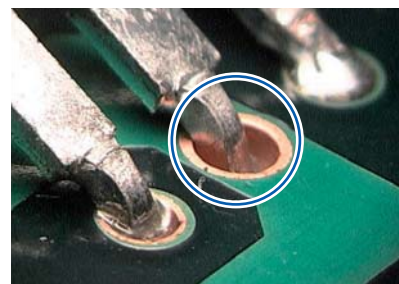
Picture 133: Insufficient through hole wetting

Solder does not wet to the inside of a through hole using a normal tip. Using a forked tip makes application of solder easy providing sufficient heat to form a micro dip well around the tip of the soldering iron. Because heat resistance of wire solder flux is high, failure to work with a tip that is equal to or below temperature recommendation will lead to poor solder joint quality.

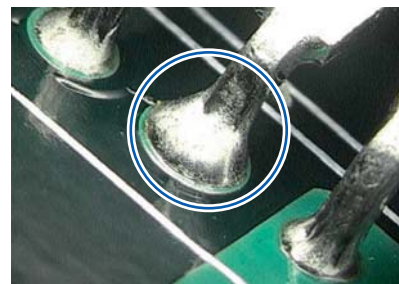
Picture 135: Good wetting with a multi-layer board

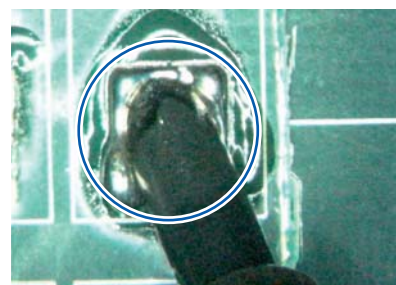
Solder does not melt even with a soldering iron tip at 380 degrees. Solder melts immediately at 320 degrees with a 'C' cut or forked soldering tip. (Pictures 136, 137)

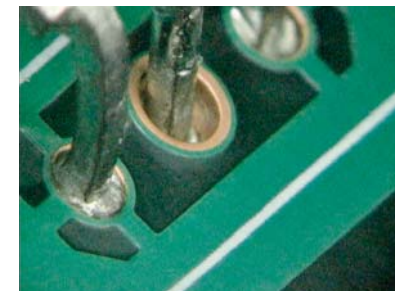
Picture 138: Insufficient through hole wetting

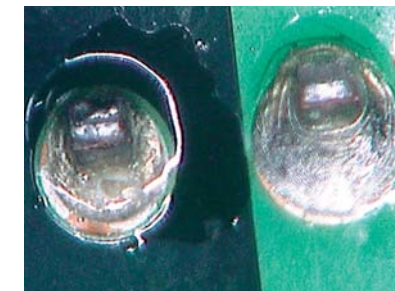
Picture 139: Lead surface is good

Through hole corrections cannot be made by adding solder on to the part surface because the added and old solder in the hole may not melt together. Solder wets to the part surface by providing additional flux on to the part surface and applying heat using a forked tip iron from the lead side to melt the solder.

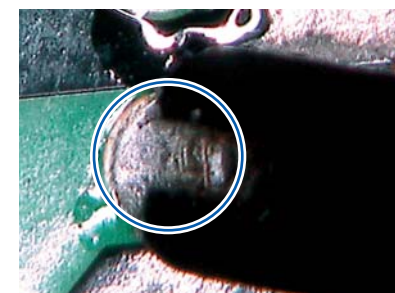
Picture 142 (enlarged view of picture 141)

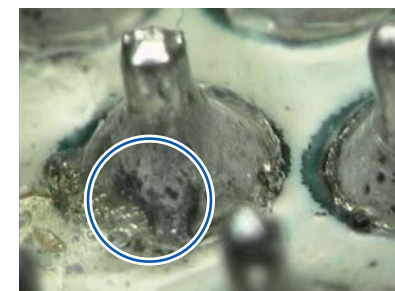
Picture 144

Air bubbles are visible in the residual flux because the soldering iron tip was too small to provide sufficient heat. A void is likely in the through hole.

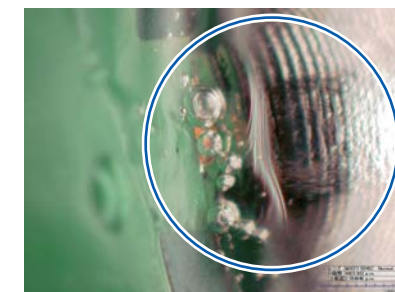
Picture 148 (enlarged view of "a" from picture 147)

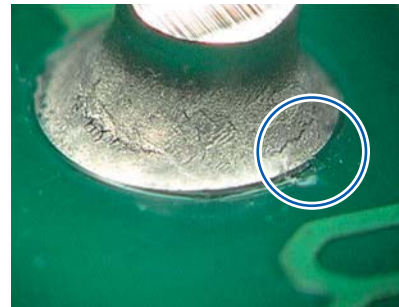
Picture 153: The small bubbles on the side of the fillet indicate the possibility of a void in the hole.

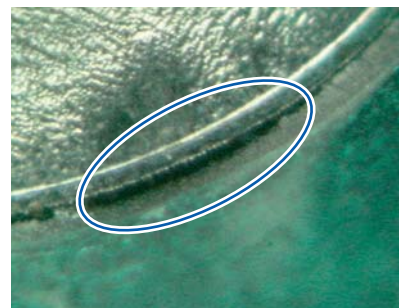
Picture 156: High solder well temperature causes land stripping

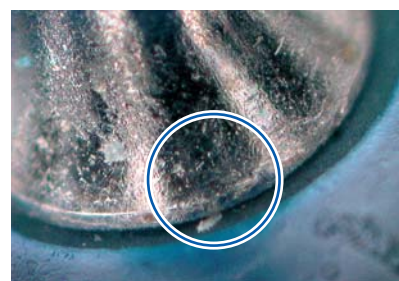
Picture 160: Land stripping and residual flux are visible on the bottom of the fillet.

The Hirox KH-7700 digital microscope allows for observation of halation by rotating the lens to change the angle of observation. This method can be used to check the status of residual flux. (MXG-5040RZ lens) In this case, the presence or absence of residual flux also indicates the presence of absence of land stripping.

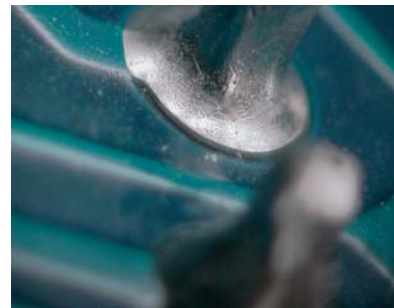
Picture 161: Insufficient hole wetting

With the Hirox KH-7700 digital microscope, you can rotate the lens to change the angle of observation and acquire a different view of the same point. (Pictures 162) This rotation also causes the lighting effect to change. (Pictures 161)

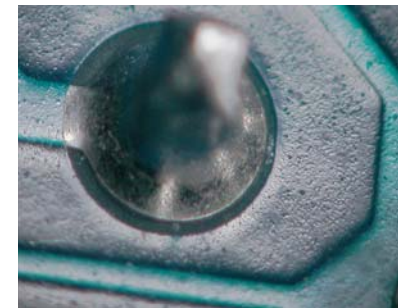
Picture 162: Forked soldering iron tip

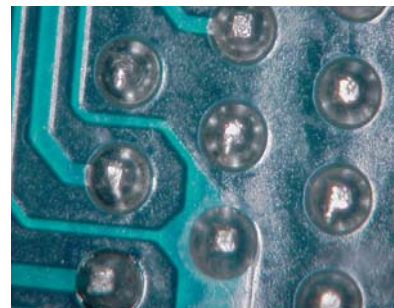
Picture 163: Good wetting even on 4-layer boards

Changing the angle of observation gives a different view of the same land. (Pictures 163 and 164)

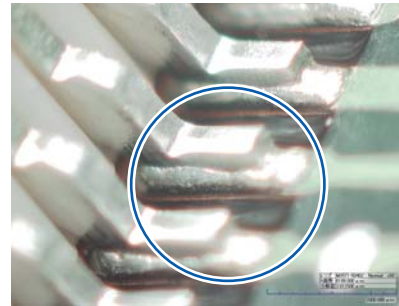
Picture 171: Sample from Picture 171 observed through KH-7700

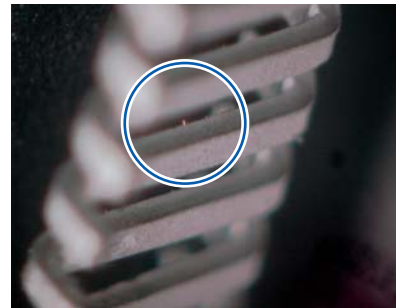
Picture 173

Rotating the lens and recording video, functions both available with the Hirox KH-7700 digital microscope, enhances observation. Normally, observations are made by first specifying an area for observation with optical equipment and then using a SEM, especially when observing whiskers. Microscopes that can observe the leads deep on the board while recording video are extremely important tools for observation.

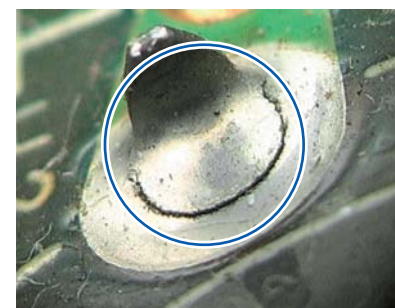
Below are pictures of a working 15 year old TV that we took apart. The parts repaired by hand, using lead solder, were not significantly affected by heat. Yet the repairs are of poor quality. Moreover, although the QFP flow is problematic, they too have not been affected by heat. However, parts that have been affected by heat are clearly broken.
